# Specialty Paper Manufacturer

## Detecting Cold Streaks in Specialty High-Gloss Paper

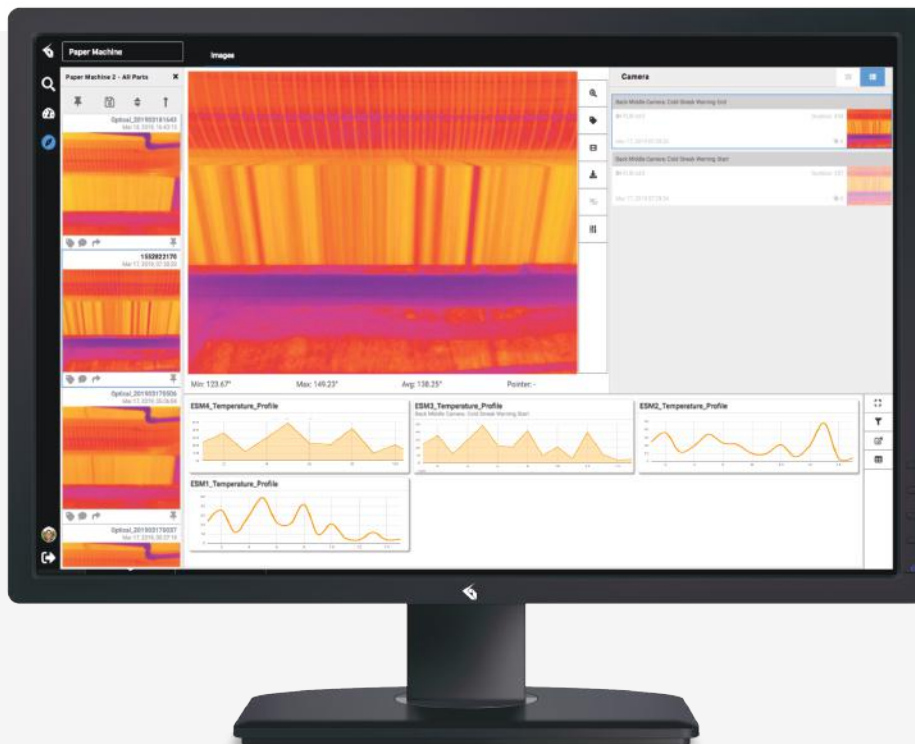
Figure 3.  
Screenshot of real-time  
temperature profiles

Following a trial period to refine the algorithm and ensure accuracy, communication to the machines' respective PLCs is enabled. Calender stacks are automatically opened upon detection of cold streaks allowing operators to clean the roll covers and prevent surface damage.

The system also allows for more detailed analysis of temperature profiles, images, videos, and machine sensor data through the platform for troubleshooting and root cause investigations.

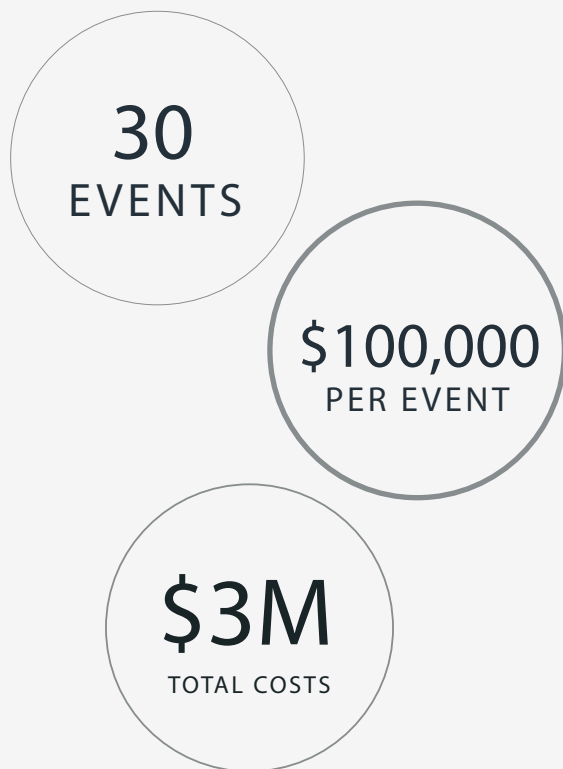
#### Before Installation (Annual Data)

Cost savings are estimated based on the total costs associated with events (damaged calender rolls requiring replacement) including unplanned, downtime, repairs, maintenance, and lost production. Costs associated with unload alarms are calculated based on an average of 5-15 minutes of production of off-spec paper per unload due to roll cover cleaning by operations.
